Anthropic impacts on the mangrove ecosystem of Requenguela beach, in the municipality of Icapuí - CE

The work identifies the main anthropic actions that degrade and unbalance the environment, especially the mangrove ecosystem, and presents a proposal for the recovery of a fragment of mangrove forest on the beach of Requenguela, in the municipality of Icapuí, state of Ceará, Brazil. To identify and analyze anthropic actions, a field visit was conducted to verify the preponderant factors for the environmental degradation of the ecosystem studied. It is noteworthy that the intensely anthropized area on this beach has an extension of approximately 12.86 hectares, where 213 planting units will be deployed in the model in "islands" throughout the extension, as a proposal for recovery, each consisting of 63 black and white mangrove seedlings. It is noteworthy that it was also proposed for this study a "Dense Seed Planting" at the edge of the consolidated vegetation and in the driest area, to maximize the efforts and promote a faster recovery of the area. For the edge of the mangrove, 5,760 red mangrove seedlings will be inserted, thus totaling a planting of 19,179 seedlings over the enti

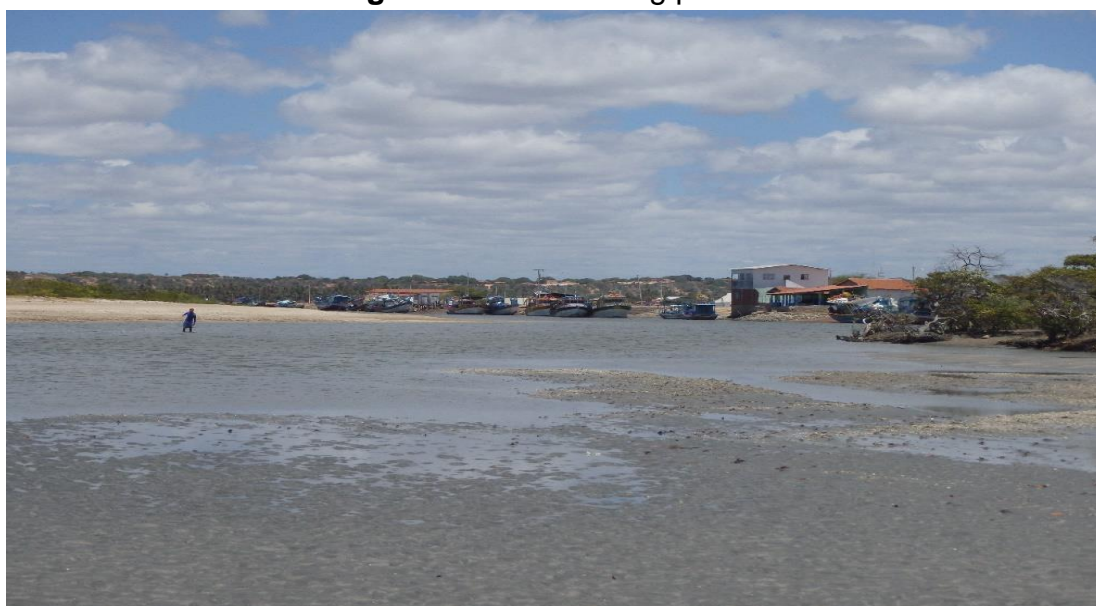
Figure 2: Boat docking point.

It was possible to identify a docking point for boats, figure 2, characterizing a port within the mangrove ecosystem, allowing the transit of small and medium-sized boats to be constant throughout the day. This port causes great environmental degradation, because it is a masonry structure built and installed on the bed of the channel formed by the movement of the tide. This construction is responsible for the compaction and depletion of the soil and silting of the channel bed (SILVA, 2012).

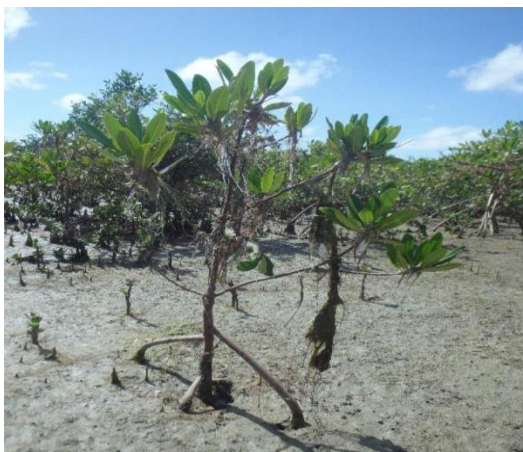
Figure 3: Red Mangrove

The red mangrove species (Figure 3) is the most common and characteristic of this type of ecosystem. It can reach a height of 6 to 12 meters, and has anchor-roots or rhizophores that serve as support and respiration, through its lenticels. Reproduction occurs through propagules when they fall to the ground; during the dry tide they open and settle in the soil. The white mangrove (Figure 4), on the other hand, is smaller in stature, has pneumatophores, a radial, superficial root system, and is formed perpendicular to the ground. The leaves of the white mangrove have salt secretion glands to release excess salt.

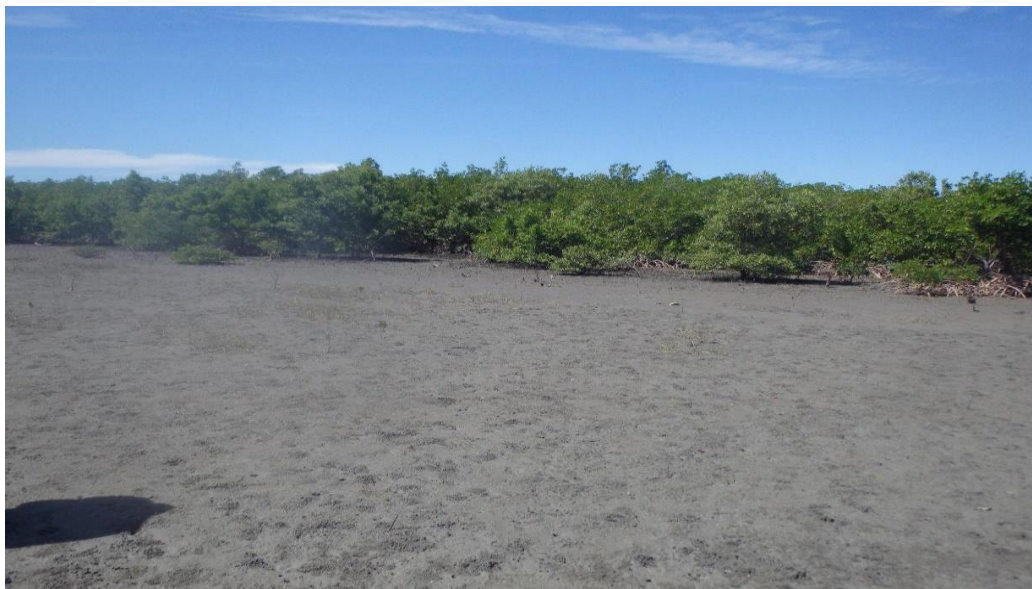
Figure 5: Mangrove substrate

The substrates of the mangrove ecosystems are characterized by a high percentage of organic matter, high salinity, little presence of oxygen, small amount of sandy material. Although the substrate is rich in nutrients, it is hypertoxic and hypersaline. With this, the mangrove has developed adaptations for this type of environment such as: the aerial roots that allow gas exchange with the environment. They have a smooth, clayey texture, with some mottling of silty and sandy material. They are characterized by a dark coloration due to the large amount of organic matter (Figure 5).

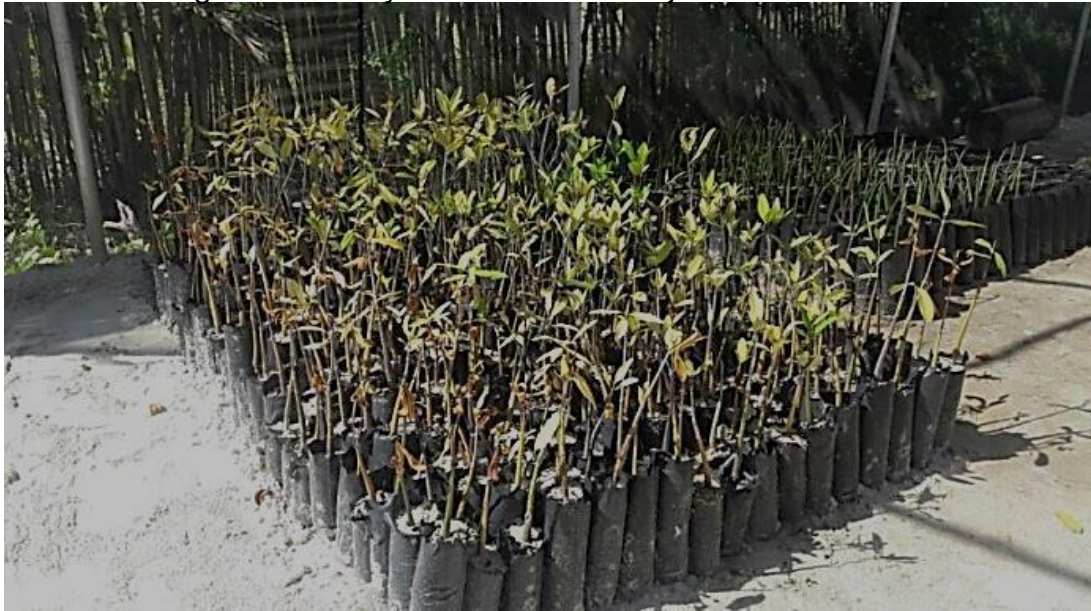
Figure 9: Seedlings from the Eye on the Water Project

Usually, two seeds are buried in a seed-bag to successfully grow at least one plant in the seedling, as seen in Figure 9. If the substrate is hard enough to introduce the seed, a hole should be drilled so that it does not break the seed root.
